USACERL Technical Report FM-93/01

Corrosion Mitigation in Civil Works Projects:
Minimization of Cavitation Repair in Turbines

Application of Thermal Spray and Ceramic Coatings and Reinforced Epoxy for Cavitation Damage Repair of Hydroelectric Turbines and Pumps

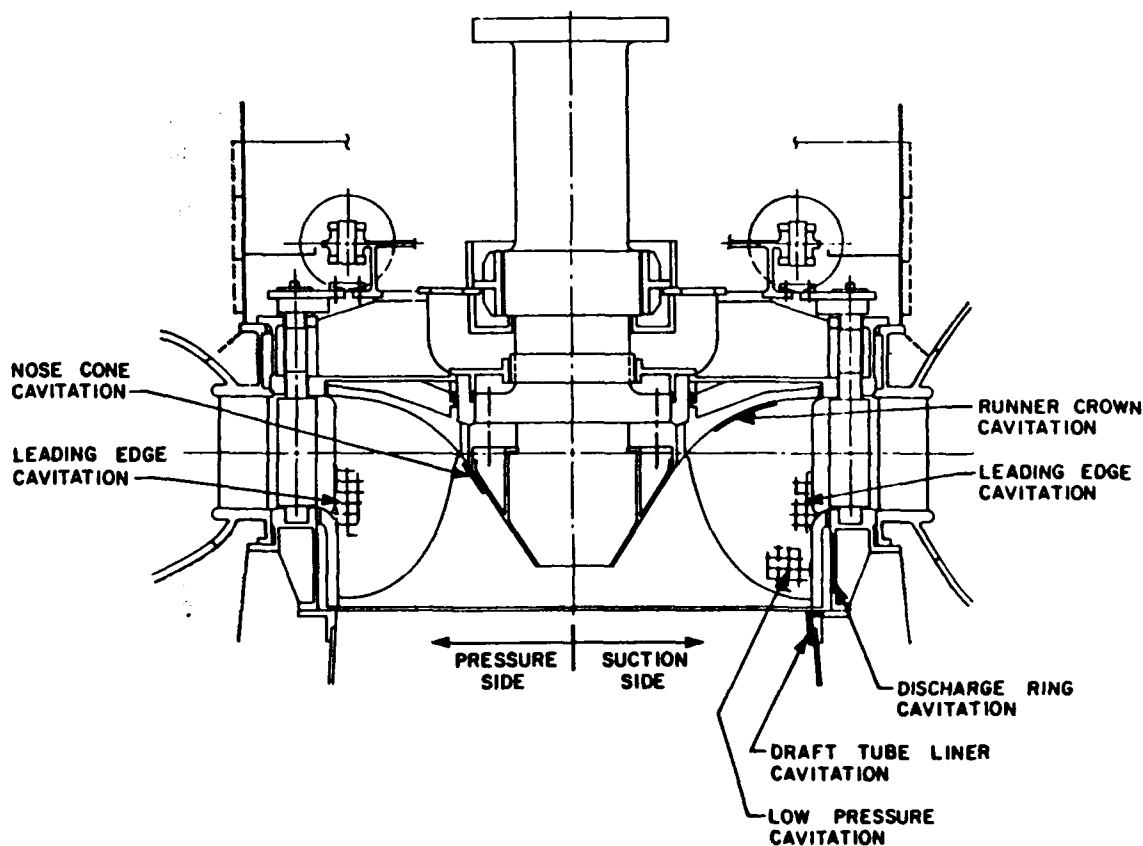
Figure 1. Typical Areas of Cavitation in Francis Turbines. (Copyright ©1986. Electric Power Research Institute. EPRI AP-4719. *Cavitation Pitting Mitigation in Hydraulic Turbines*. Reprinted with permission.)

Cavitation damage can occur to components of all reaction-type turbine equipment, including fixed-blade propeller turbine units, adjustable blade propeller turbines, and reversible Francis pump-turbines. Impulse turbines generally do not experience cavitation but are exposed to erosion. Areas on Francis units where cavitation damage can be expected to occur (Figures 1 and 2) include:

- runner blades - suction side, near band and trailing edge
- runner blades - leading edge, near the band on both the suction side and the pressure side
- runner blades - trailing edge, on suction side
- runner blades - near crown (leading edge)
- the air vents in the crown on the runner
- the discharge ring opposite the runner band
- below the band on the draft tube liner
- wicket gates sides.⁷

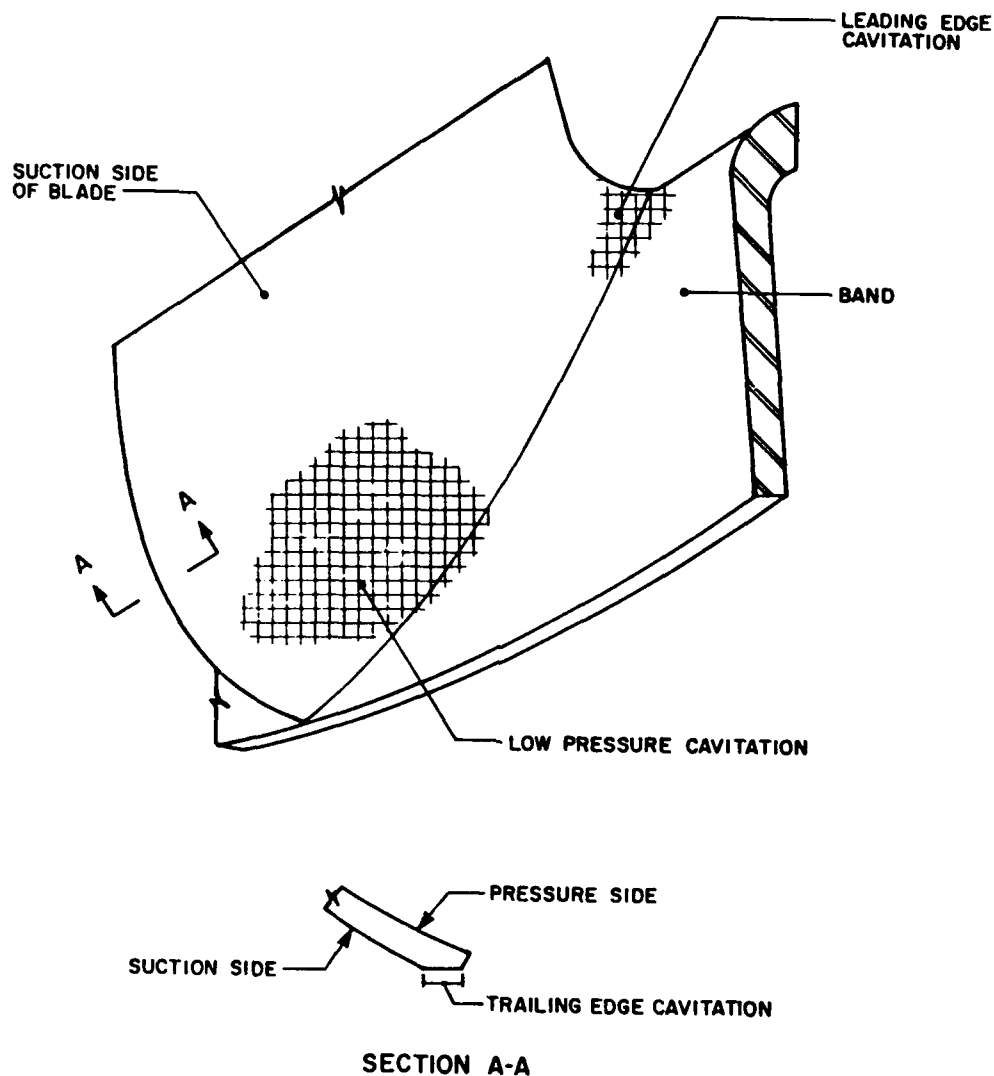
Figure 2. Areas of Cavitation on the Runner in Francis Turbines. (Copyright ©1986. Electric Power Research Institute. EPRI AP-4719. *Cavitation Pitting Mitigation in Hydraulic Turbines*. Reprinted with permission.)

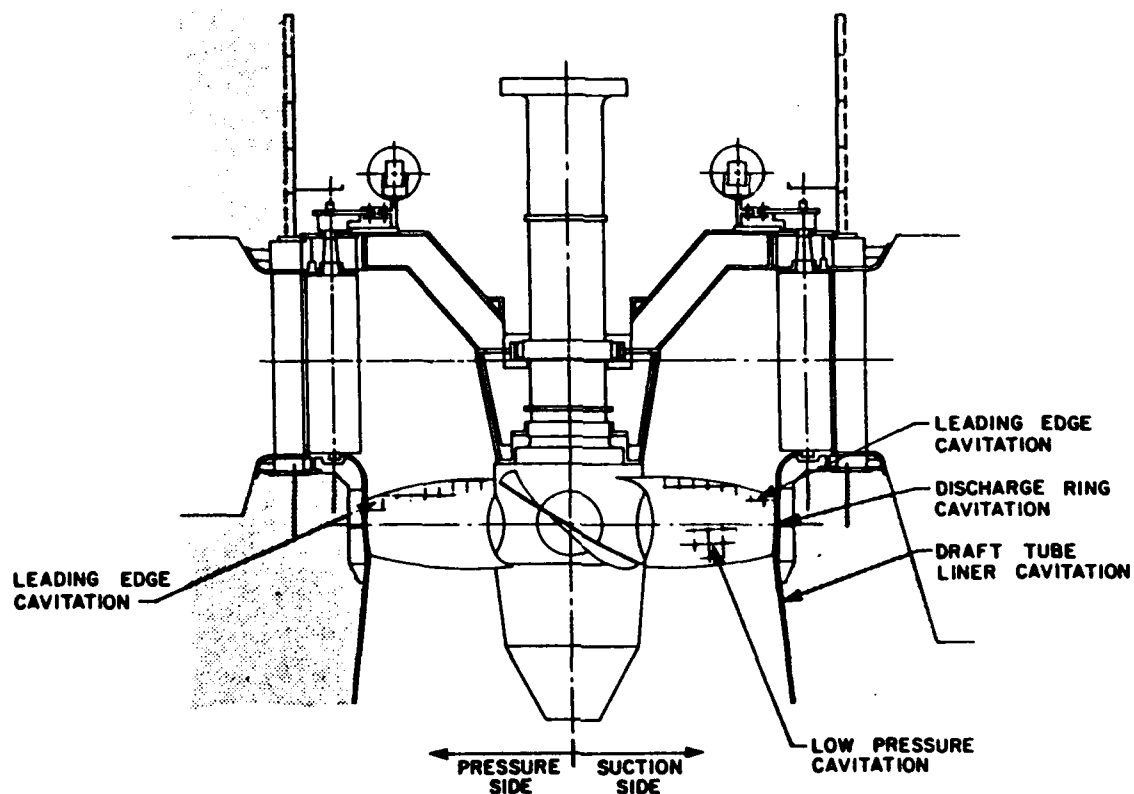
Figure 3. Typical Areas of Cavitation in Propeller Turbine. (Copyright ©1986. Electric Power Research Institute. EPRI AP-4719. *Cavitation Pitting Mitigation in Hydraulic Turbines*. Reprinted with permission.)

Areas on propeller units where cavitation damage can occur (Figures 3 and 4) include:

- runner blades - suction side from the centerline to the trailing edge
- runner blades - leading edge, both the suction side and the pressure side
- runner blades - trailing edge, pressure side
- runner blade - suction side of the peripheral edge
- near the runner periphery, suction side
- the runner hub, discharge ring, and draft tube liner.⁸

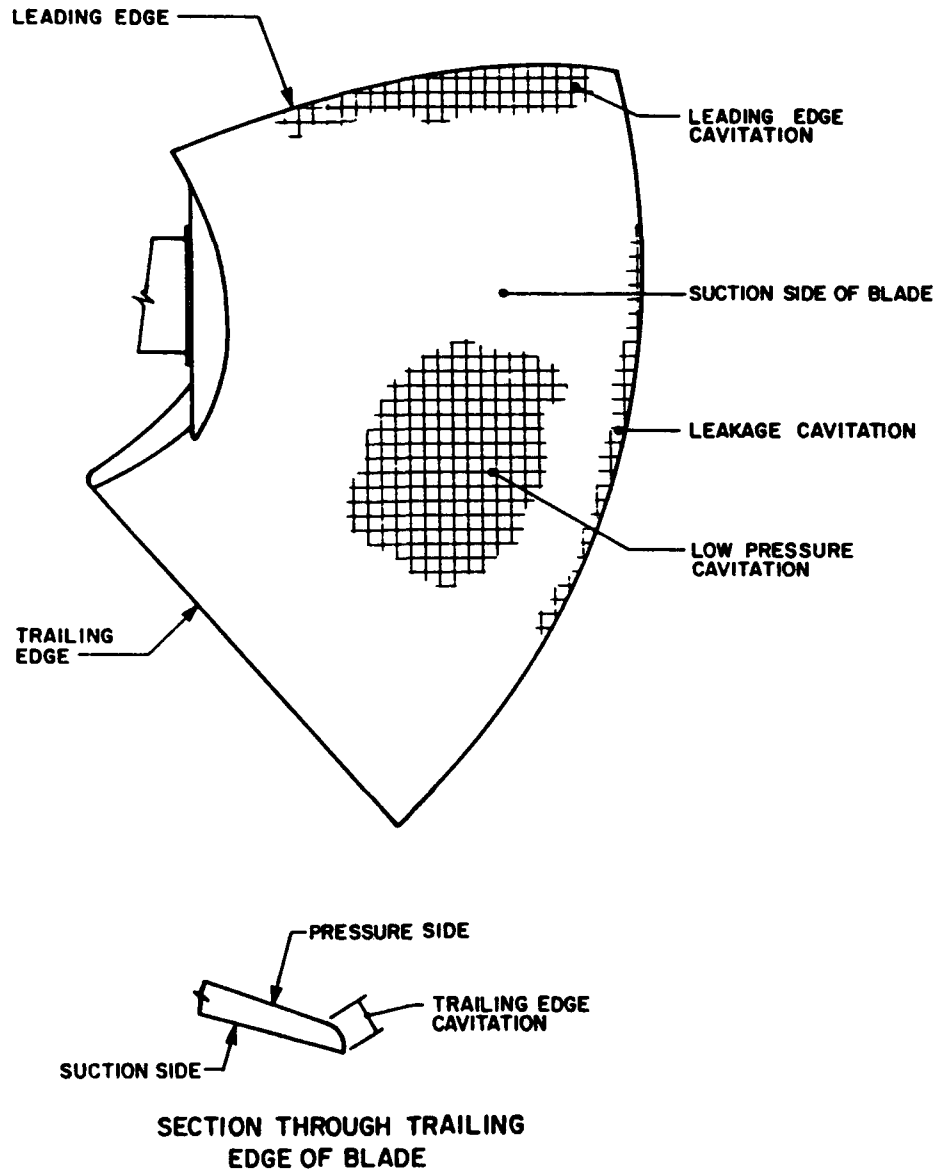
Figure 4. Areas of Cavitation on the Runner in Propeller Turbines. (Copyright ©1986. Electric Power Research Institute. EPRI AP-4719. *Cavitation Pitting Mitigation in Hydraulic Turbines*. Reprinted with permission.)

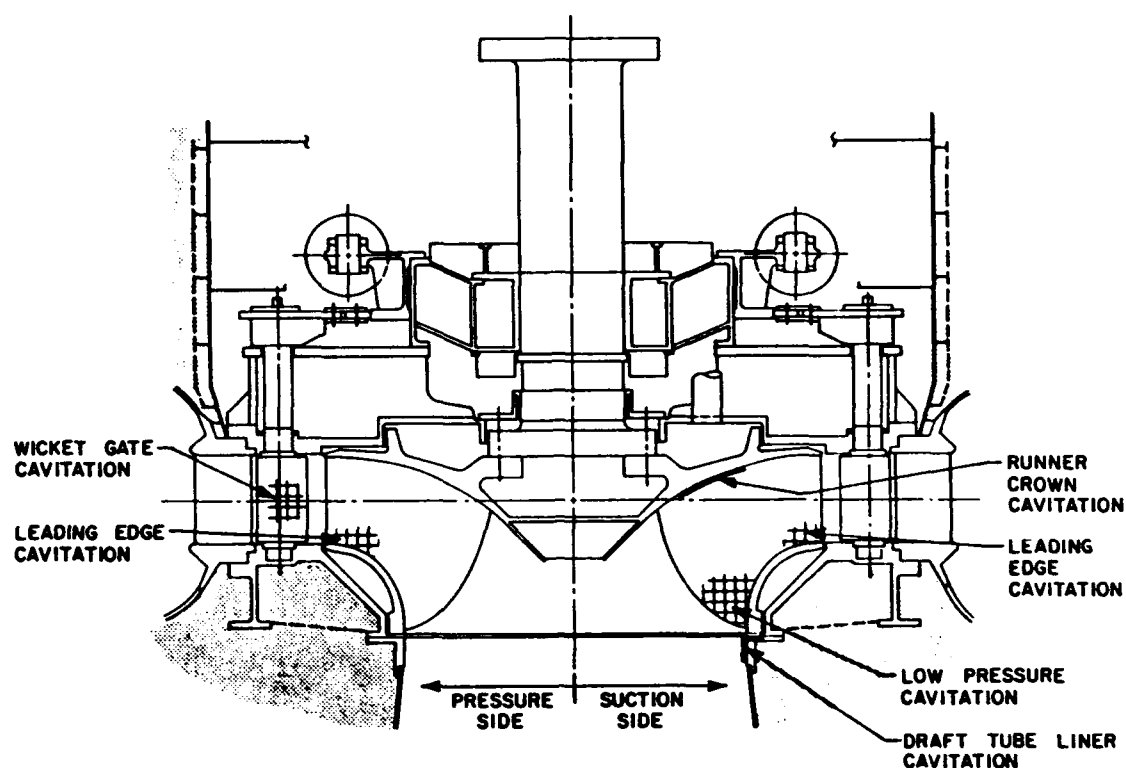
Figure 5. Typical Areas of Cavitation in Pump Turbines. (Copyright ©1986. Electric Power Research Institute. EPRI AP-4719. *Cavitation Pitting Mitigation in Hydraulic Turbines*. Reprinted with permission.)

Areas on pump-type turbines where cavitation damage can occur (Figures 5 and 6) include:

- runner blades - suction side, near and at the pump leading edge
- runner blades - pressure side, at pump leading edge
- runner blades - both the suction side and pressure side, near the band at turbine leading edge
- crown, or runner blade, turbine leading edge near crown
- the discharge ring near the runner
- under the bottom of the band on the draft tube liner
- below the band on the draft tube liner
- wicket gates sides.⁹

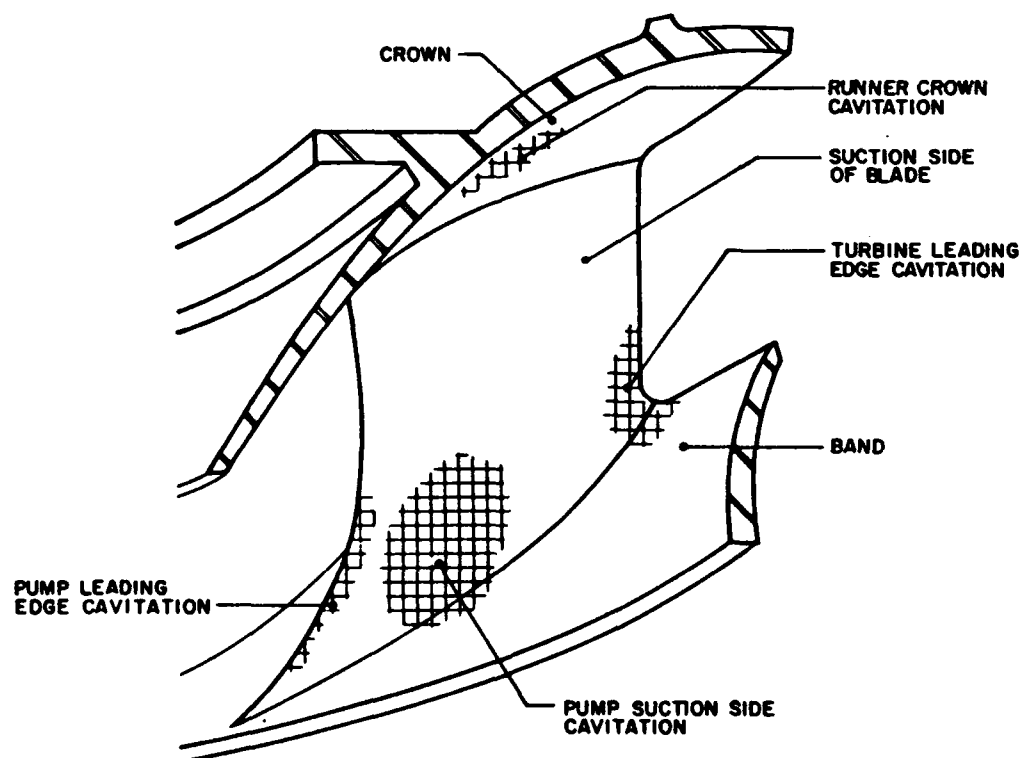
Figure 6. Areas of Cavitation on the Runner in Pump Turbines. (Copyright ©1986. Electric Power Research Institute. EPRI AP-4719. *Cavitation Pitting Mitigation in Hydraulic Turbines*. Reprinted with permission.)

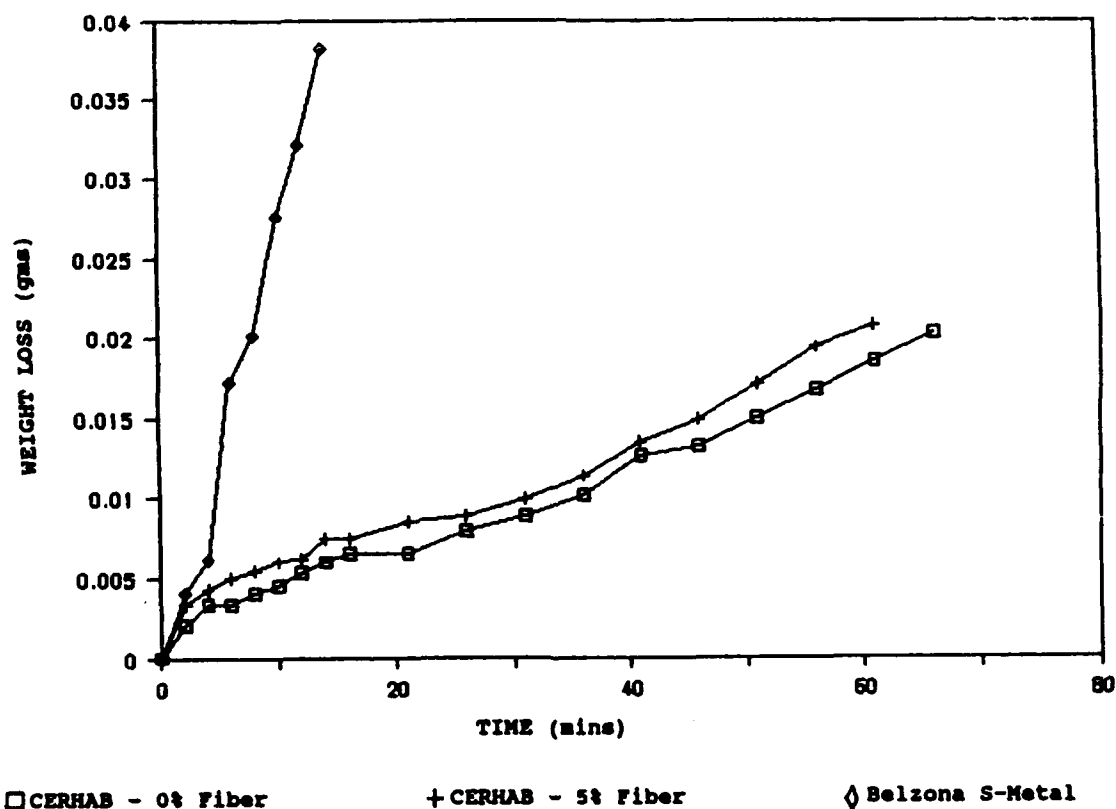
Figure 7. Vibratory Cavitation Test Results Comparing CERHAB With 0% and 5% Fiber to Epoxy.

The results of the shop-sprayed CERHAB coating were mixed. Cavitation resistance testing was performed using a vibratory cavitation unit. A commercially available reinforced epoxy was tested with formulations of CERHAB that had different weight percents of added fibers. Figures 7 through 9 contain the data of CERHAB with fiber additions of 5, 7, and 10 percent, respectively. The tests were also performed with a reinforced epoxy and CERHAB with no fiber added for baseline information. Figure 7 shows that after approximately 10 minutes of testing, the epoxy had lost more than 6 times the weight of either of the two CERHAB compositions. The CERHAB composition with no fiber reinforcing performed slightly better during the entire test. It appears that the added fracture toughness imparted to

the enamel by the fibers has little effect on the coating's cavitation resistance. Figures 8 and 9 show similar cavitation resistance behavior for the coatings. It is interesting that as the weight percent of the fiber reinforcement increases, the resistance to cavitation damage slightly decreases. It appears that there may be an optimum fiber weight percent to give maximum performance, as is true with many fiber reinforced coating systems.

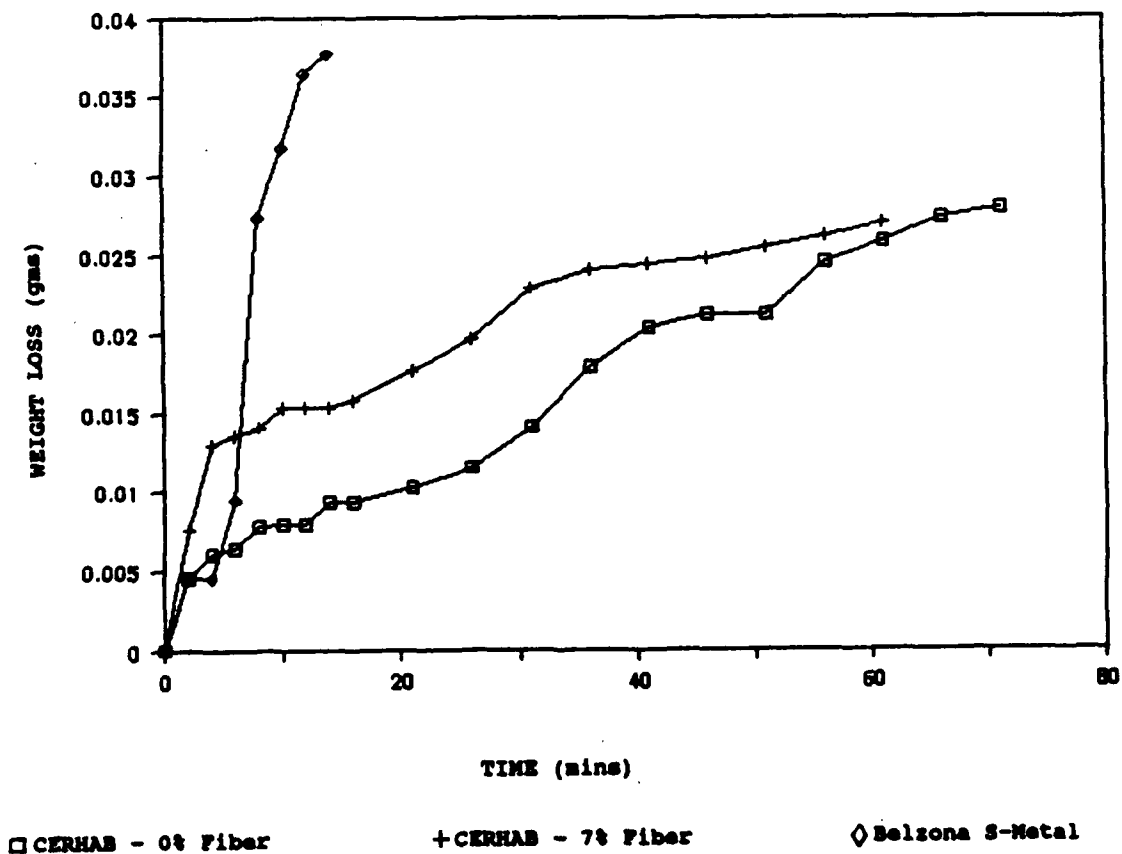
Figure 8. Vibratory Cavitation Test Results Comparing CERHAB With 0% and 7% Fiber to Epoxy.

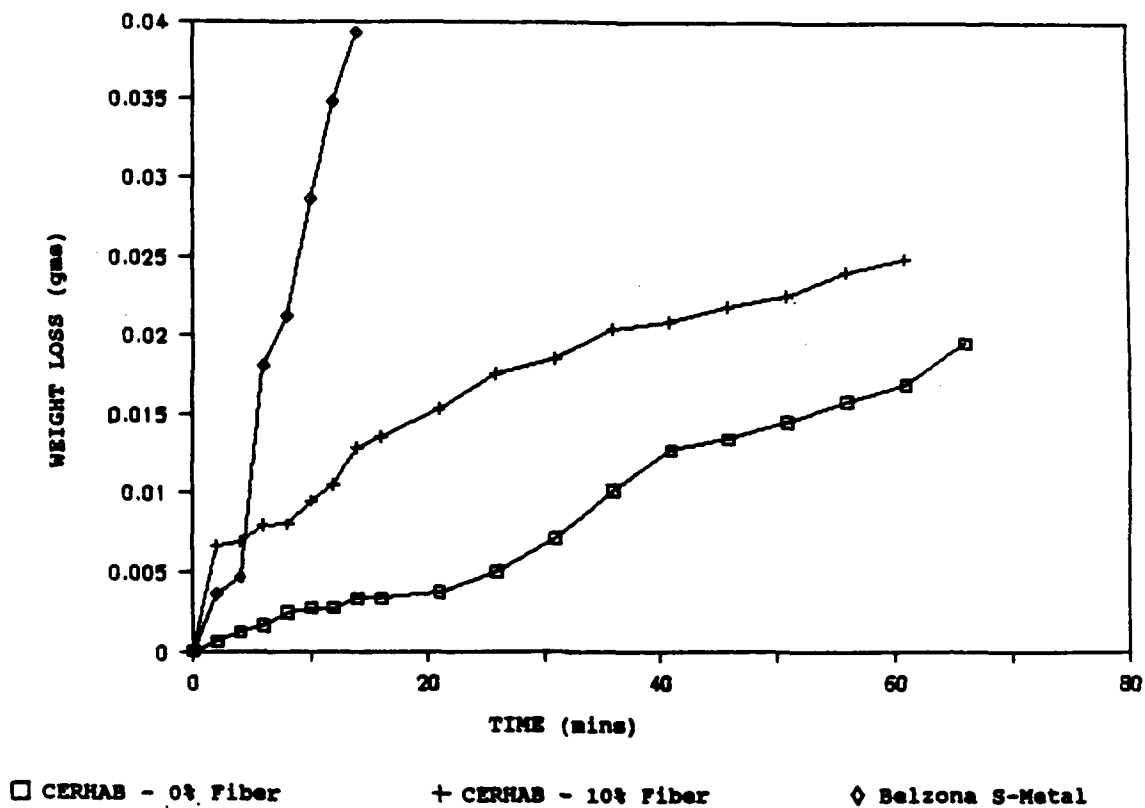
Figure 9. Vibratory Cavitation Test Results Comparing CERHAB With 0% and 10% Fiber to Epoxy.

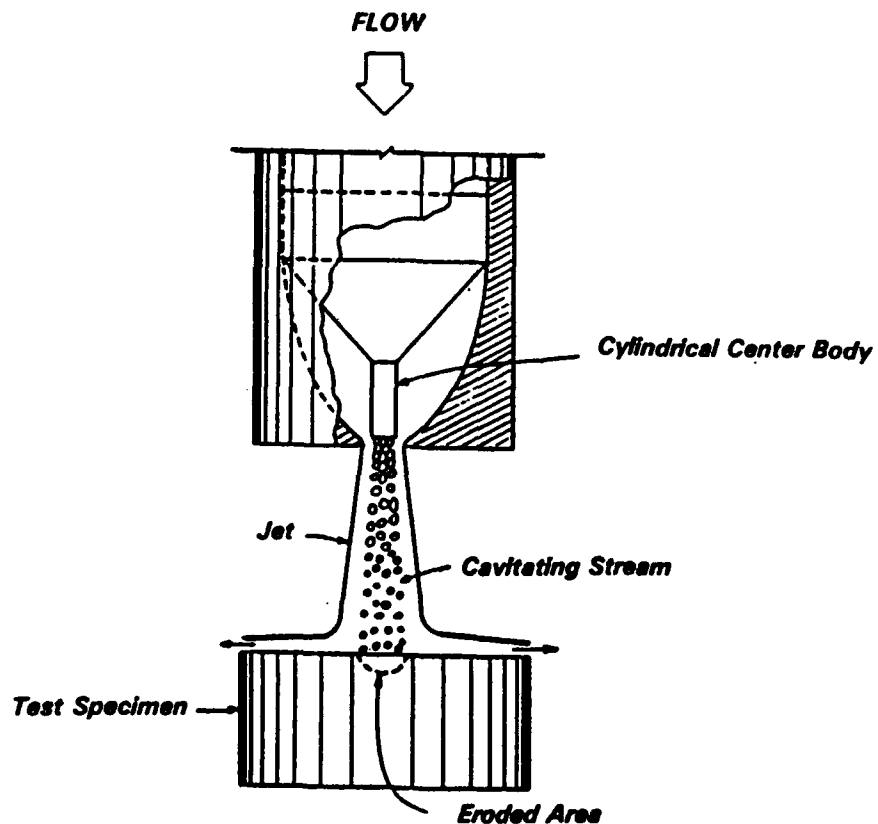
Figure 10. The Tennessee Valley Authority Cavitating Jet System.

The cavitating jet system, Figure 10, operated by the Tennessee Valley Authority's (TVA's) Engineering Laboratory consists of a cartridge-style filter, a three-plunger positive displacement pump rated for a flow of 3 gallons per minute (GPM) at 10,000 pounds per square inch (psi), and a 25 horsepower electric motor. The unit has a flow control valve, to set the operating flow and pressure, an unloading valve, to temporarily interrupt a test for specimen removal and weighing, and a bypass valve, as a safety backup and for pressure relief. Gauges monitor the inlet and discharge pressures during operation and record the accumulated operating hours for maintenance records. The test chamber is constructed of stainless steel, 18 in. x 18 in. x 18 in., and has windows for monitoring the specimens.

The TVA has conducted a limited number of tests on highly resistant materials at 10,000 and 6000 psi. A 4000 psi pressure was used as a standard for accelerated cavitation tests with base materials and weld overlays. It was found that soft coatings experienced mechanical damage, therefore they were subjected to a reduced pressure of 2000 psi. The test samples were located approximately 0.875 in. from the nozzle tip.

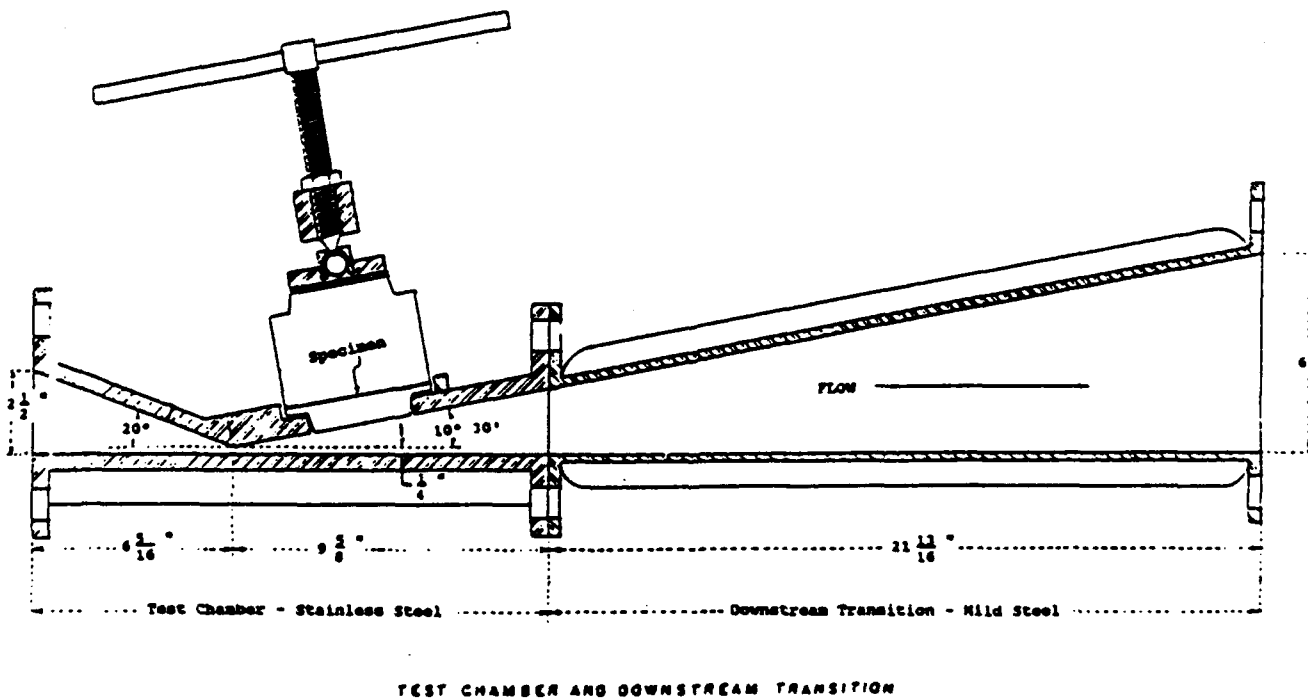
Figure 11. U.S. Bureau of Standards Venturi-Flow Cavitation Testing Unit.

The venturi-flow system, Figure 11, is capable of testing metallic coated as well as concrete specimens. The inlet pressure is controllable and directly affects the water velocity that flows through the throat. By adjusting the inlet pressure, a variety of cavitating environments may be simulated.
